FMEA, monitoring, retrofit and redesign of insulated rail joints

A Bracciali, G Megna

Department of Industrial Engineering, University of Florence, via di Santa Marta 3, 50139 Florence, Italy

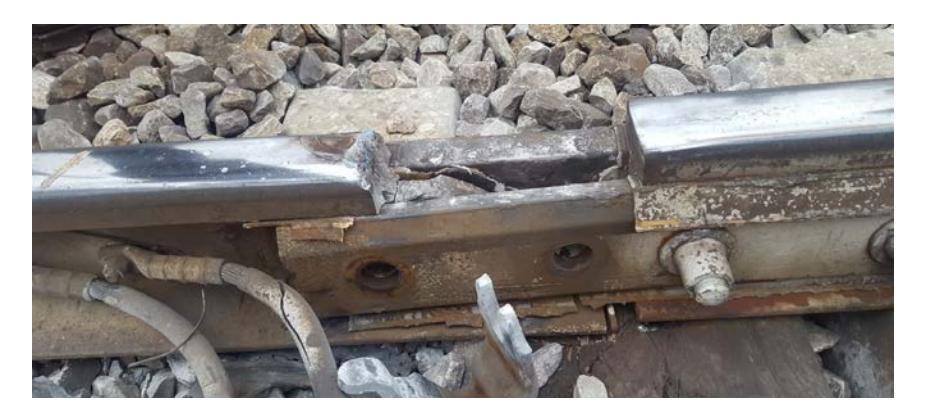
Investigations readily discovered that the two rail ends that constitute the joint where were separated by approximately 25 mm and that the downstream rail was heavily battered by the passing wheels. An around 23 cm piece of rail eventually detached, ending under one of the train wheels, producing a "jump" and the consequent derailment. The fragment showed signs of the classical "defect 135 – star crack from fishbolt hole" as described by the UIC 712 code, that is probably the most common critical and symptomatic defect that regularly affects bolted joints.

Figure 1. The joint broken in Pioltello on 25.01.2018. The train travels right to left. It can be seen that downstream portion of the IRJ is completely destroyed. The flown away portion of the railhead got stuck under a wheel causing the derailment of the train.

It was said previously that the train derailment was originated by the interaction of a trail wheel with a slice of rail section that detached from the downstream portion of the joint.

- star cracks appeared starting from the downstream hole close to endpost, and cracks progressed until the rail slice detached;
- as observed, the rails displaced by more than 20 mm, so debonding was a clear contributor to the final failure;
- during the movement the fishbolts certainly crushed the small fiberglass tubes insulating them from the fishplates and the rail web.

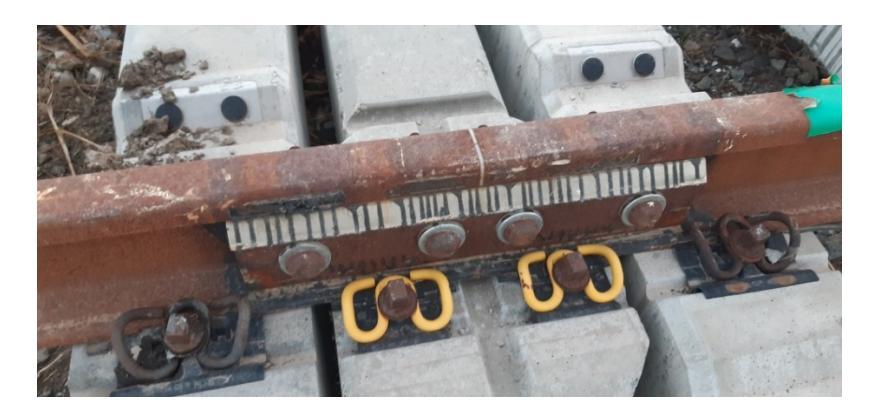
Figure 3. The IRJ currently used in Italy pictured before installation. A specifically widened sleepers was developed to (theoretically) better support the IRJ. Hollow sleepers to pass cables can be seen. Sleeper spacing is adjusted during installation but results to be non-standard with tamping difficulties.

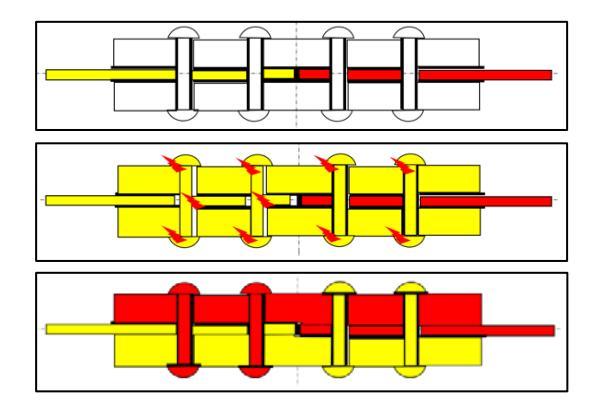
Figure 4a shows the conventional joint as assembled in a plant, tested and correctly installed on a railway line. Track circuits power supply and insulation element geometry are such that rails facing in the IRJ are at different electrical voltage (red and yellow). The fishplates are neutral, as they are insulated from both the rails and the fishbolts.

Figure 4b describes what happened in Pioltello. The left (yellow) rail displaced by a large distance (more than 20 mm) destroying both fishbolts/rails and fishbolts/fishplates tubes. As a result, both fishplates "became yellow", therefore getting the same electrical potential as the left rail. This condition stayed for a long time until the whole joint was destroyed without losing its insulation and therefore without shortening the track circuit. This is the root cause of the Pioltello accident: the missed track circuit occupation given by an IRJ that was mechanically destroyed.

Figure 4b. Horizontal cross section of an IRJ when the left rail moved to the left bringing the fishbolts in contact with the rail web and the fishplates.

A short redesign scenario was then approached that readily showed that there are several possible insulation arrangements that fulfil the requested condition "mechanical failure \rightarrow electrical failure \rightarrow interruption of service \rightarrow no risks". Figure 4c shows a possible layout in which:

- a) each rail in electrically connected to one of the fishplates and
- b) fishbolts are insulated only on one side by an insulated washer (no fiberglass tubes)

Figure 4c. Horizontal cross section of a modified IRJ in standard condition. Any movement leads to short circuiting the rails.

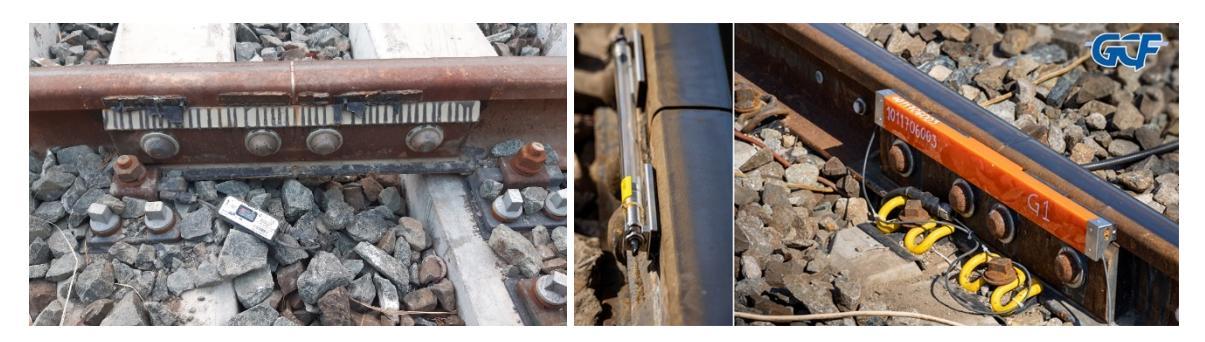
Figure 5. Left: electromechanical IRJ found detached along a railway line (photo A. Bracciali). Right: optical IRJ sensor (from [6]).

- the sensor is applied in the IRJ manufacturing plant but tends to be detached during handling of the joint during the trackworks;
- On-Track Machines (OTMs) with rubber tyres used during trackworks interfere with the bonded sensor, further detaching it;
- no connection to the signalling system was provided until today, making the check nearly useless (one type of device has just a mechanical device that is redundant as IRJ opening can easily be checked visually).
