FMEA, monitoring, retrofit and redesign of insulated rail joints

A Bracciali, G Megna

Department of Industrial Engineering, University of Florence, via di Santa Marta 3, 50139 Florence, Italy

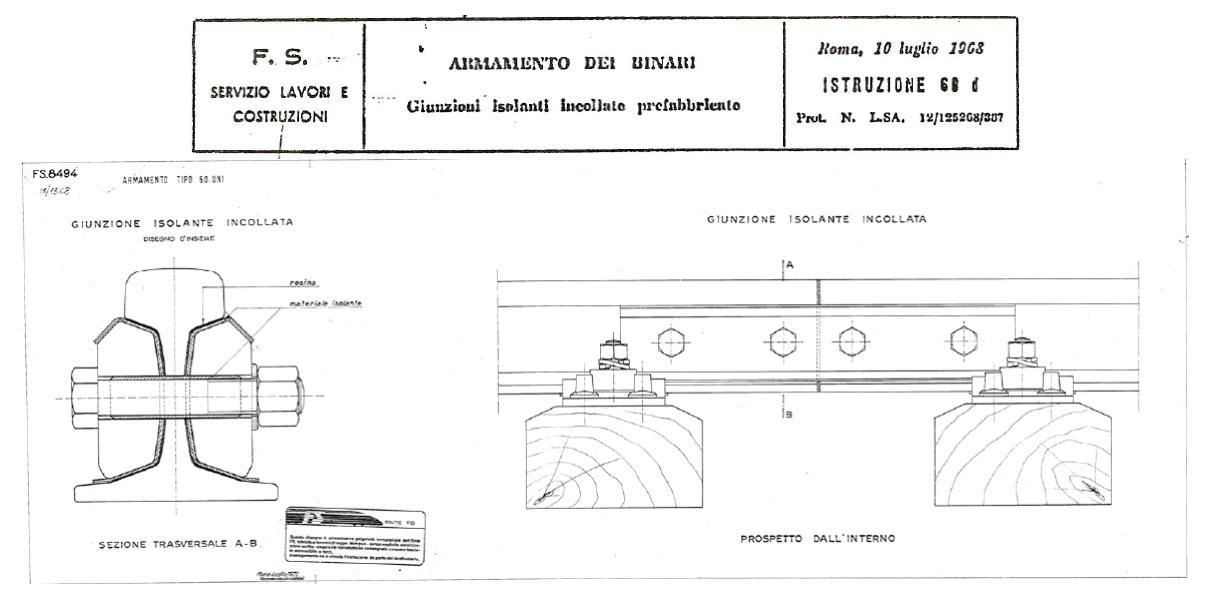
The drawing of IRJ may date back to the 60s. Small modifications may have been introduced in materials and or in the sequence of operations but basically the design remained the same. The drawing in figure 2 shows the original prefabricated joint that was introduced in Italy in 1968. The

current drawing is very similar, the only difference being the replacement of C960 fishbolt with Huck bolts.

Figure 2. Reproduction of the drawing of the standard prefabricated IRJ in Italy since 1968.

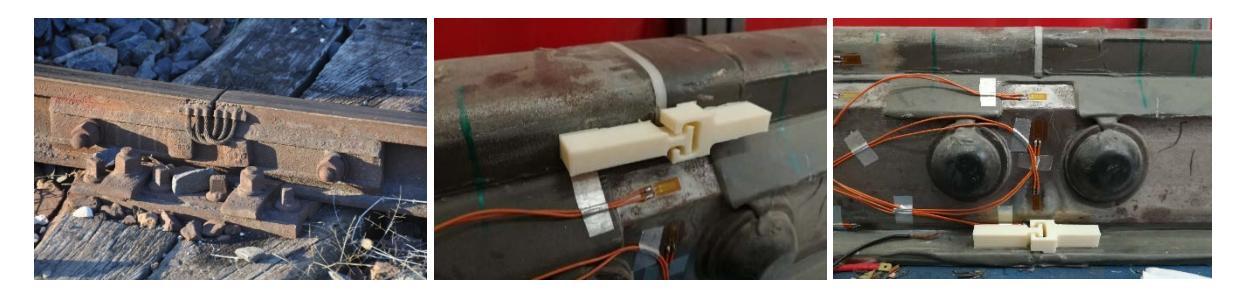
Figure 6. Left: current return conductors in an electrified yard with old rails resting on wooden sleepers (photo A. Bracciali). Safety switch produced with rapid prototyping technique bonded to field side of railheads (centre) and to rail bottom (right).

A different approach to intrinsic safety was proposed by the authors taking inspiration from the past practice of short-circuiting the rails when many yards were electrified. As shown in figure 6, a rather common practice was to weld conductive cables to the field side of railheads to ensure the return of current to electric substations. Similarly to this design, a pair of stainless steel elements forming a switch was developed. The use of conductive glue was forecasted to avoid welding that is not accepted anymore in main line applications.

Beyond the greatest advantage of simplicity of manufacturing and installation and a ridiculous cost, the main advantage of this device is that it automatically stops traffic when the IRJ debonds, ensuring the highest possible safety. A formal FMEA analysis was not conducted because of the simplicity of the device and because the proposal was not even considered by the railway industry.
